THE HOUSE AT GLENMONT

HOME OF THOMAS EDISON

Historic Structure Report

THE HOUSE AT GLENMONT
HISTORIC STRUCTURE REPORT

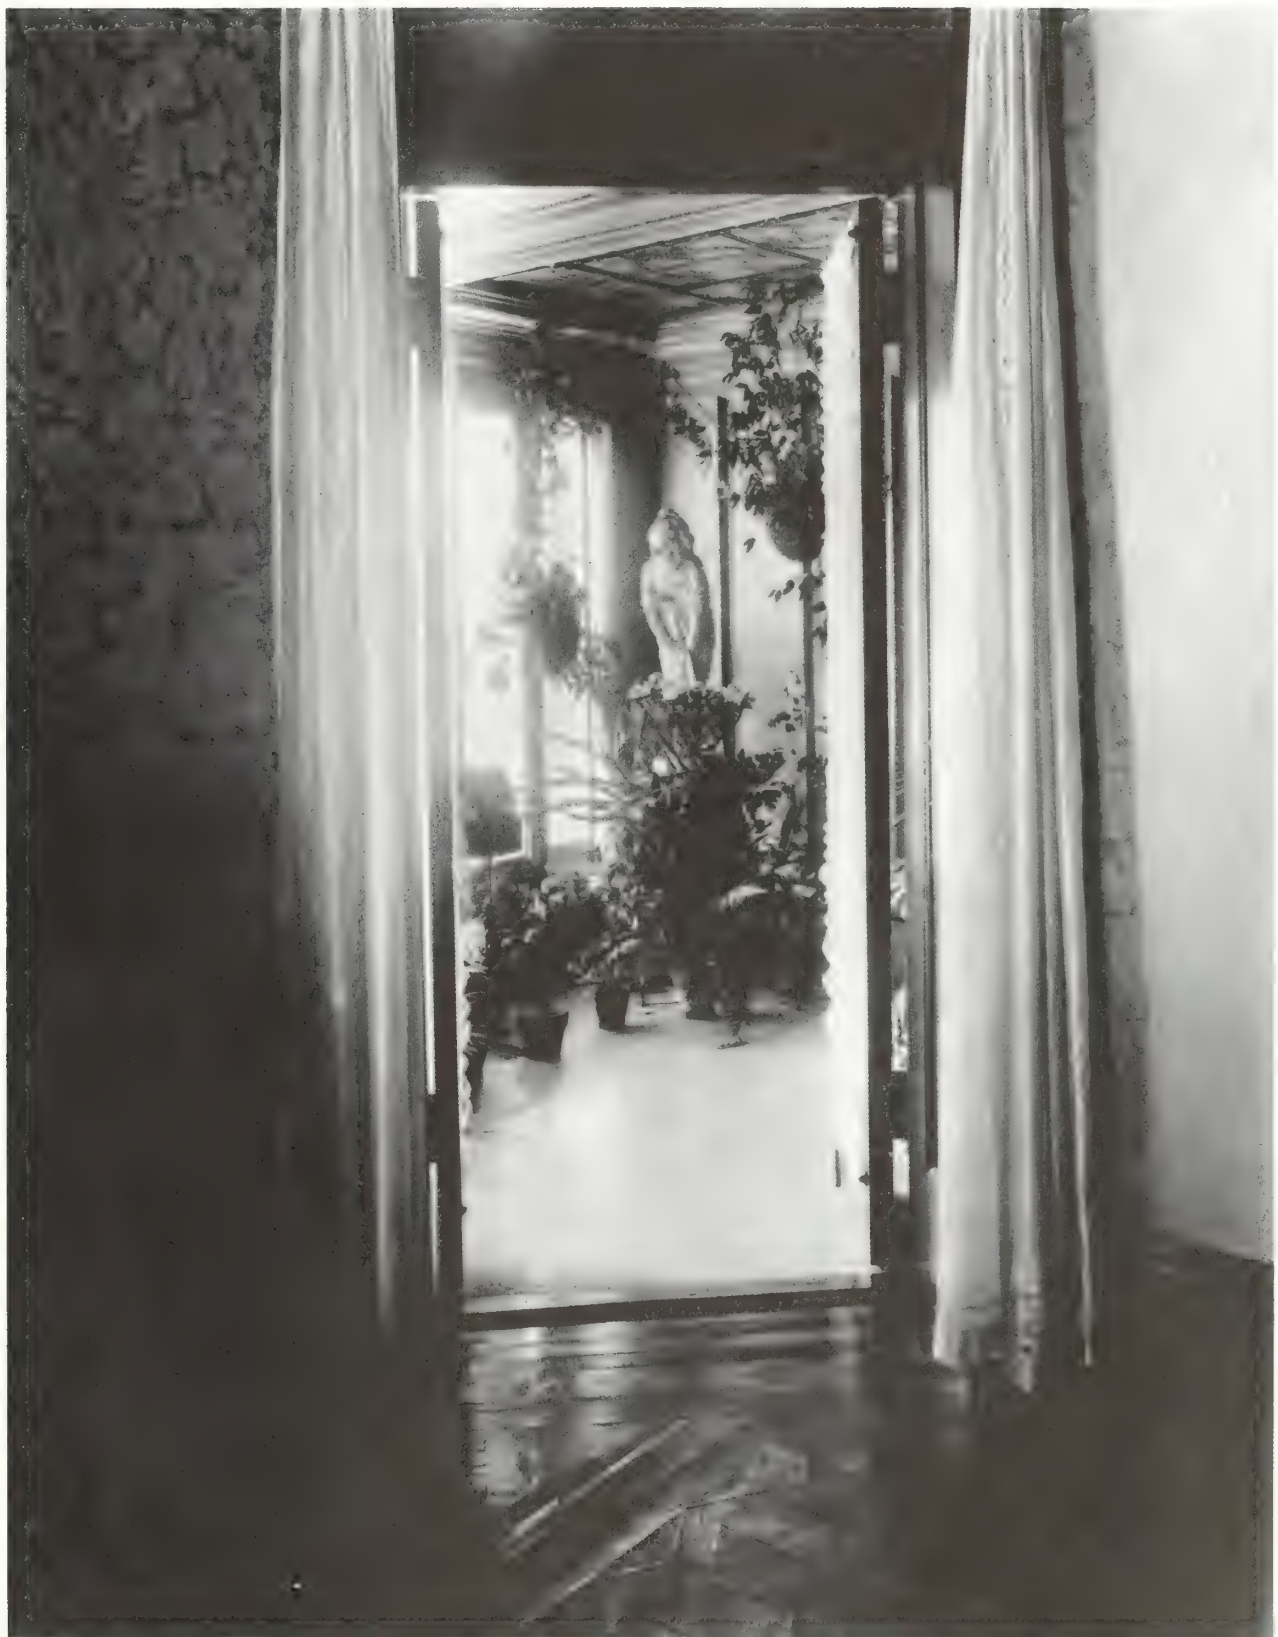
Figure 113. Fern Room (Room 116), looking northwest through the Drawing Room doorway, 1916.

looking southwest; it shows potted plants on the shelf, hanging plants, and palms. The other photograph is dated 1916 (fig. 113); it is a view looking towards the northwest, through the Drawing Room doorway. The room today is unchanged from its appearance in 1916.

The 1916 photograph of the room (fig. 113) is the only historical view of the floor. The floor was described by the residence appraisals of 1921, 1924, and 1931 as being “77 Sq. ft. colored ceramic [sic] floor tiling.”

A photograph of the room dated 1916 shows the northwest corner of the room, including the board-and-batten north wall and the glazed west wall (fig. 113). The residence appraisal of 1931 recorded the room’s wall features as including “90 Sq. ft. pine wall paneling” and “47 Lineal ft. 6” x 6” pine cornice.”

The glass ceiling panel is documented by the bill from architect Knowles dated January 31, 1910, which included the following entry: "Heinigke & Bowen—Leaded glass \$276." Also included in the bill was a listing for the "Geo. Hayes Co.,—Sky-light [sic] work \$55." The 1916 photograph of the room (fig. 113) shows the ceiling as it appears today.

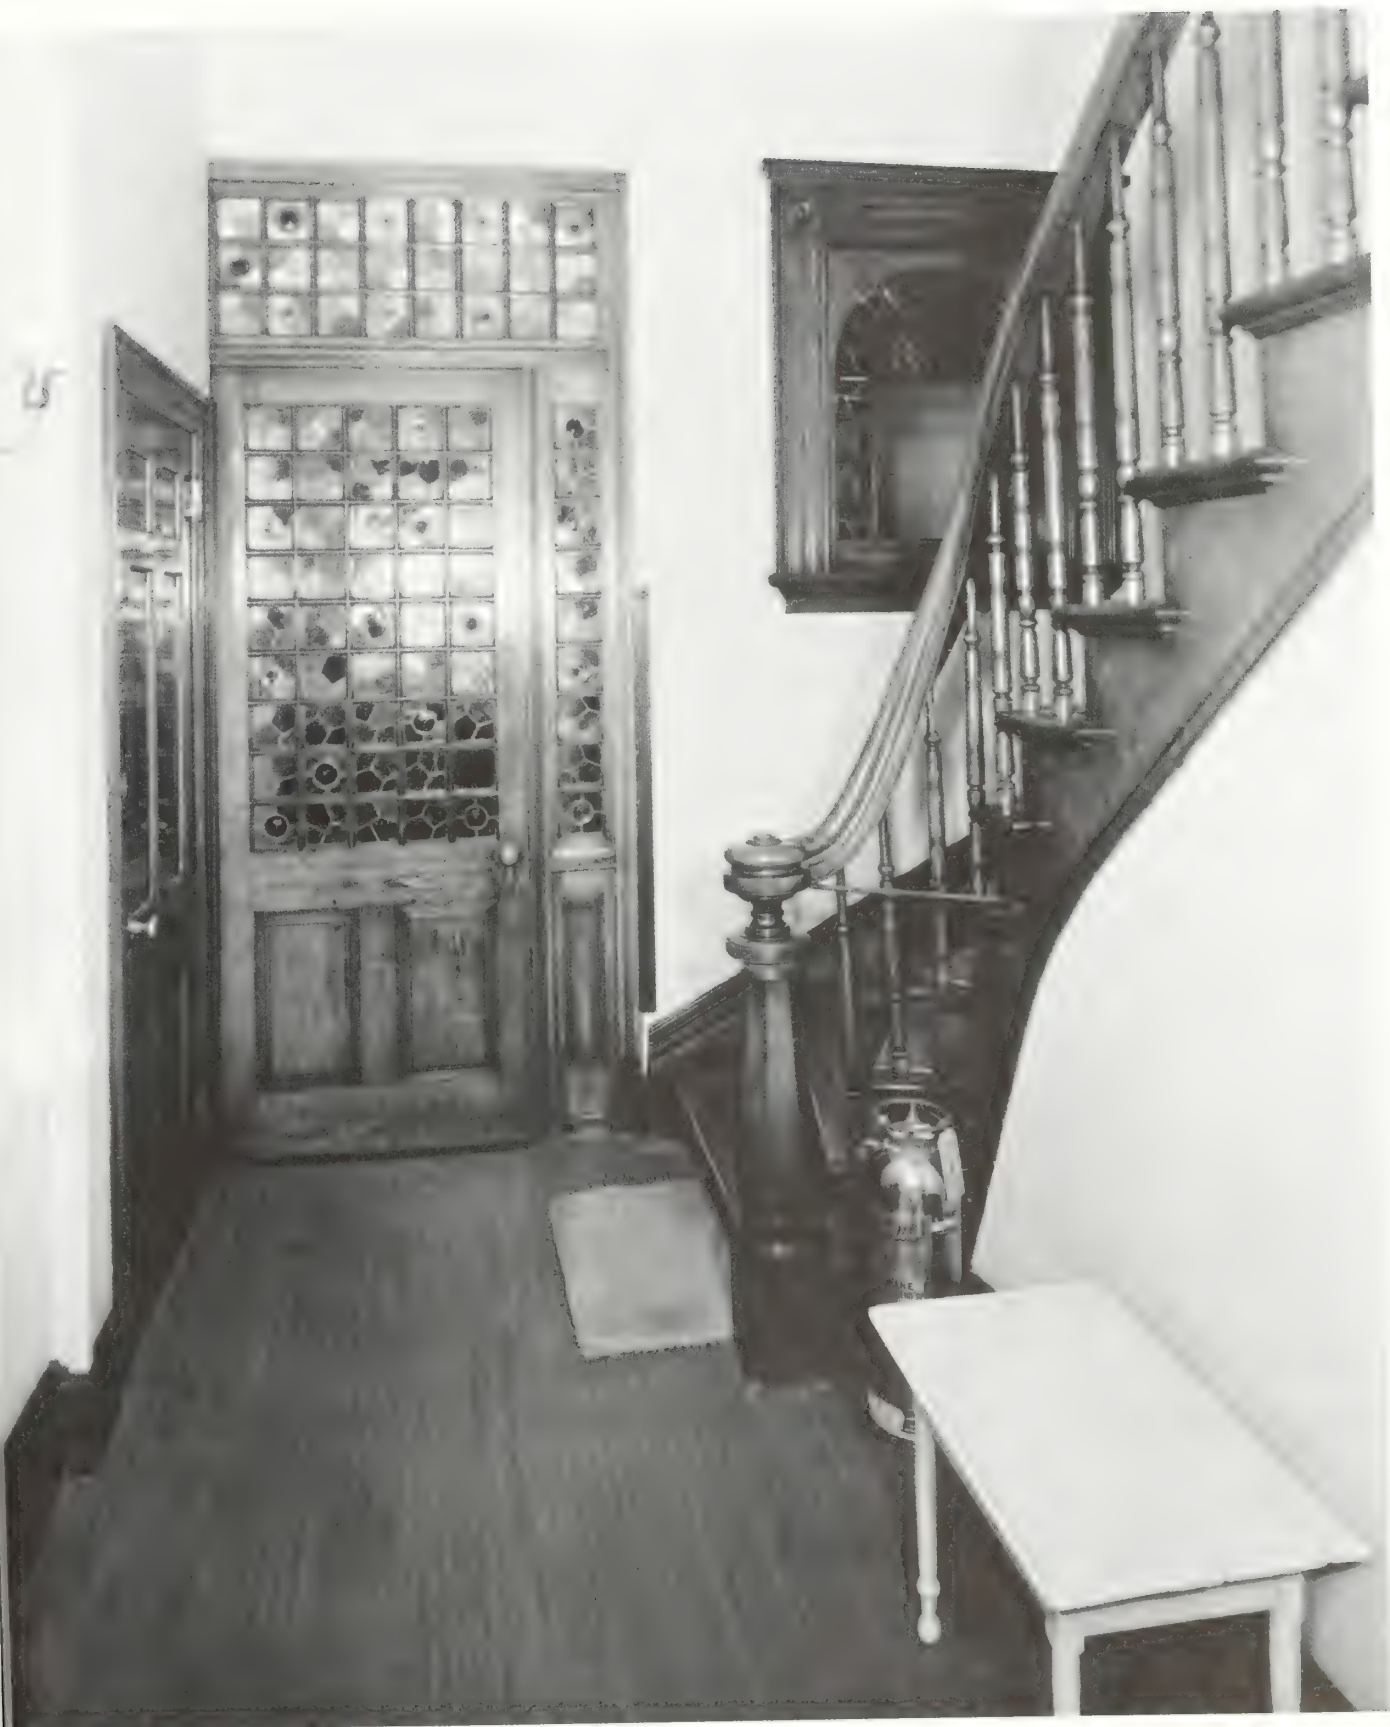
Figure 114. South part of Service Hall (Room 117), looking north, 1960.

The dumbwaiter doorway was replaced in 1943-44 by a large doorway to access the new passenger elevator installed in the dumbwaiter shaft. This doorway is documented by a photograph

of the hall dated October 21, 1960 (fig. 114). It shows a six-panel door hinged on its north side to swing outward. This door was removed, and the doorway was closed and covered with matched boarding, by the National Park Service in 1968.

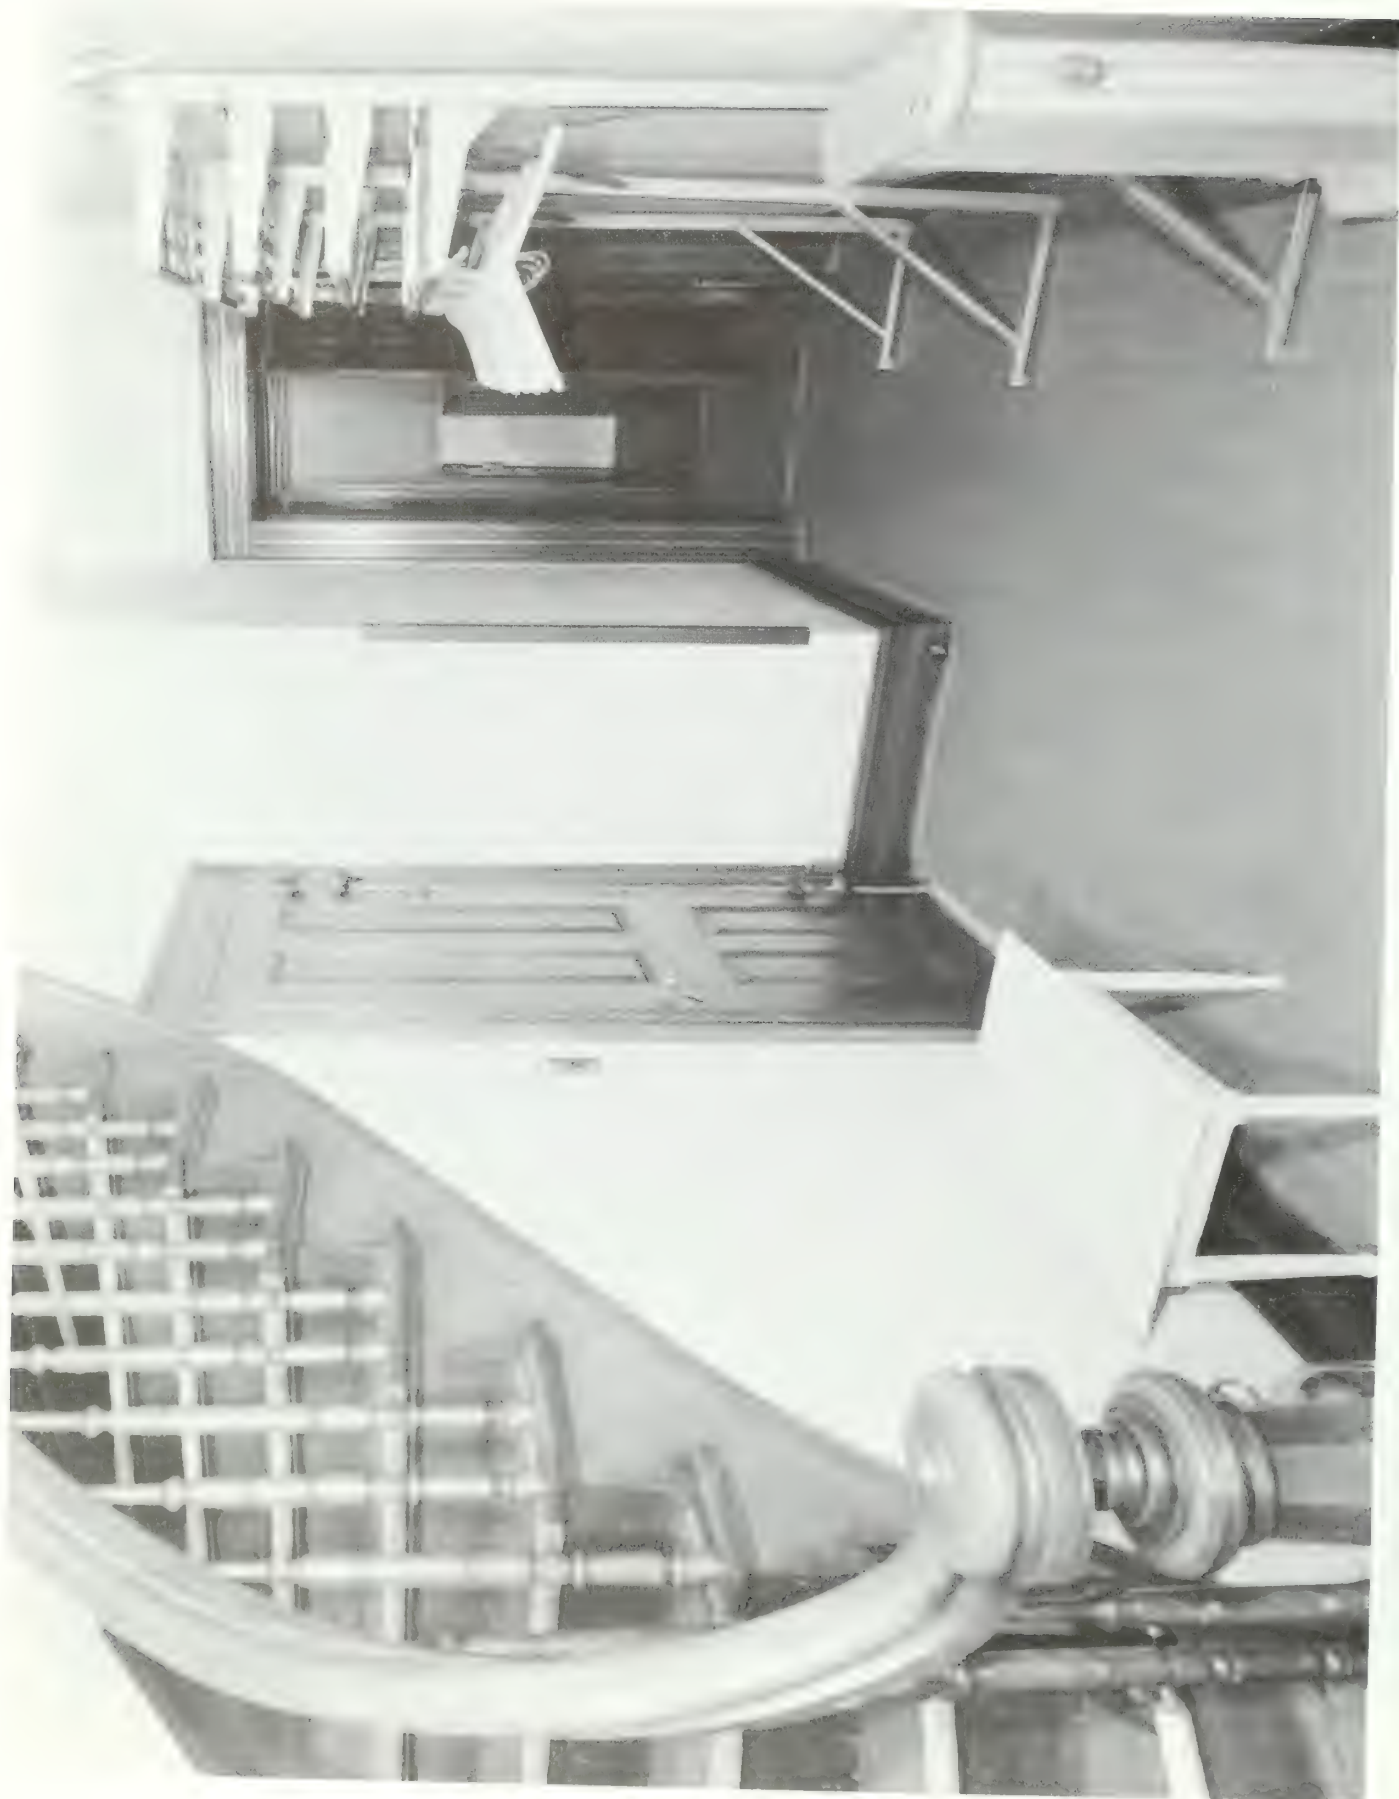
Figure 115. South part of Service Hall (Room 117), looking south, 1960.

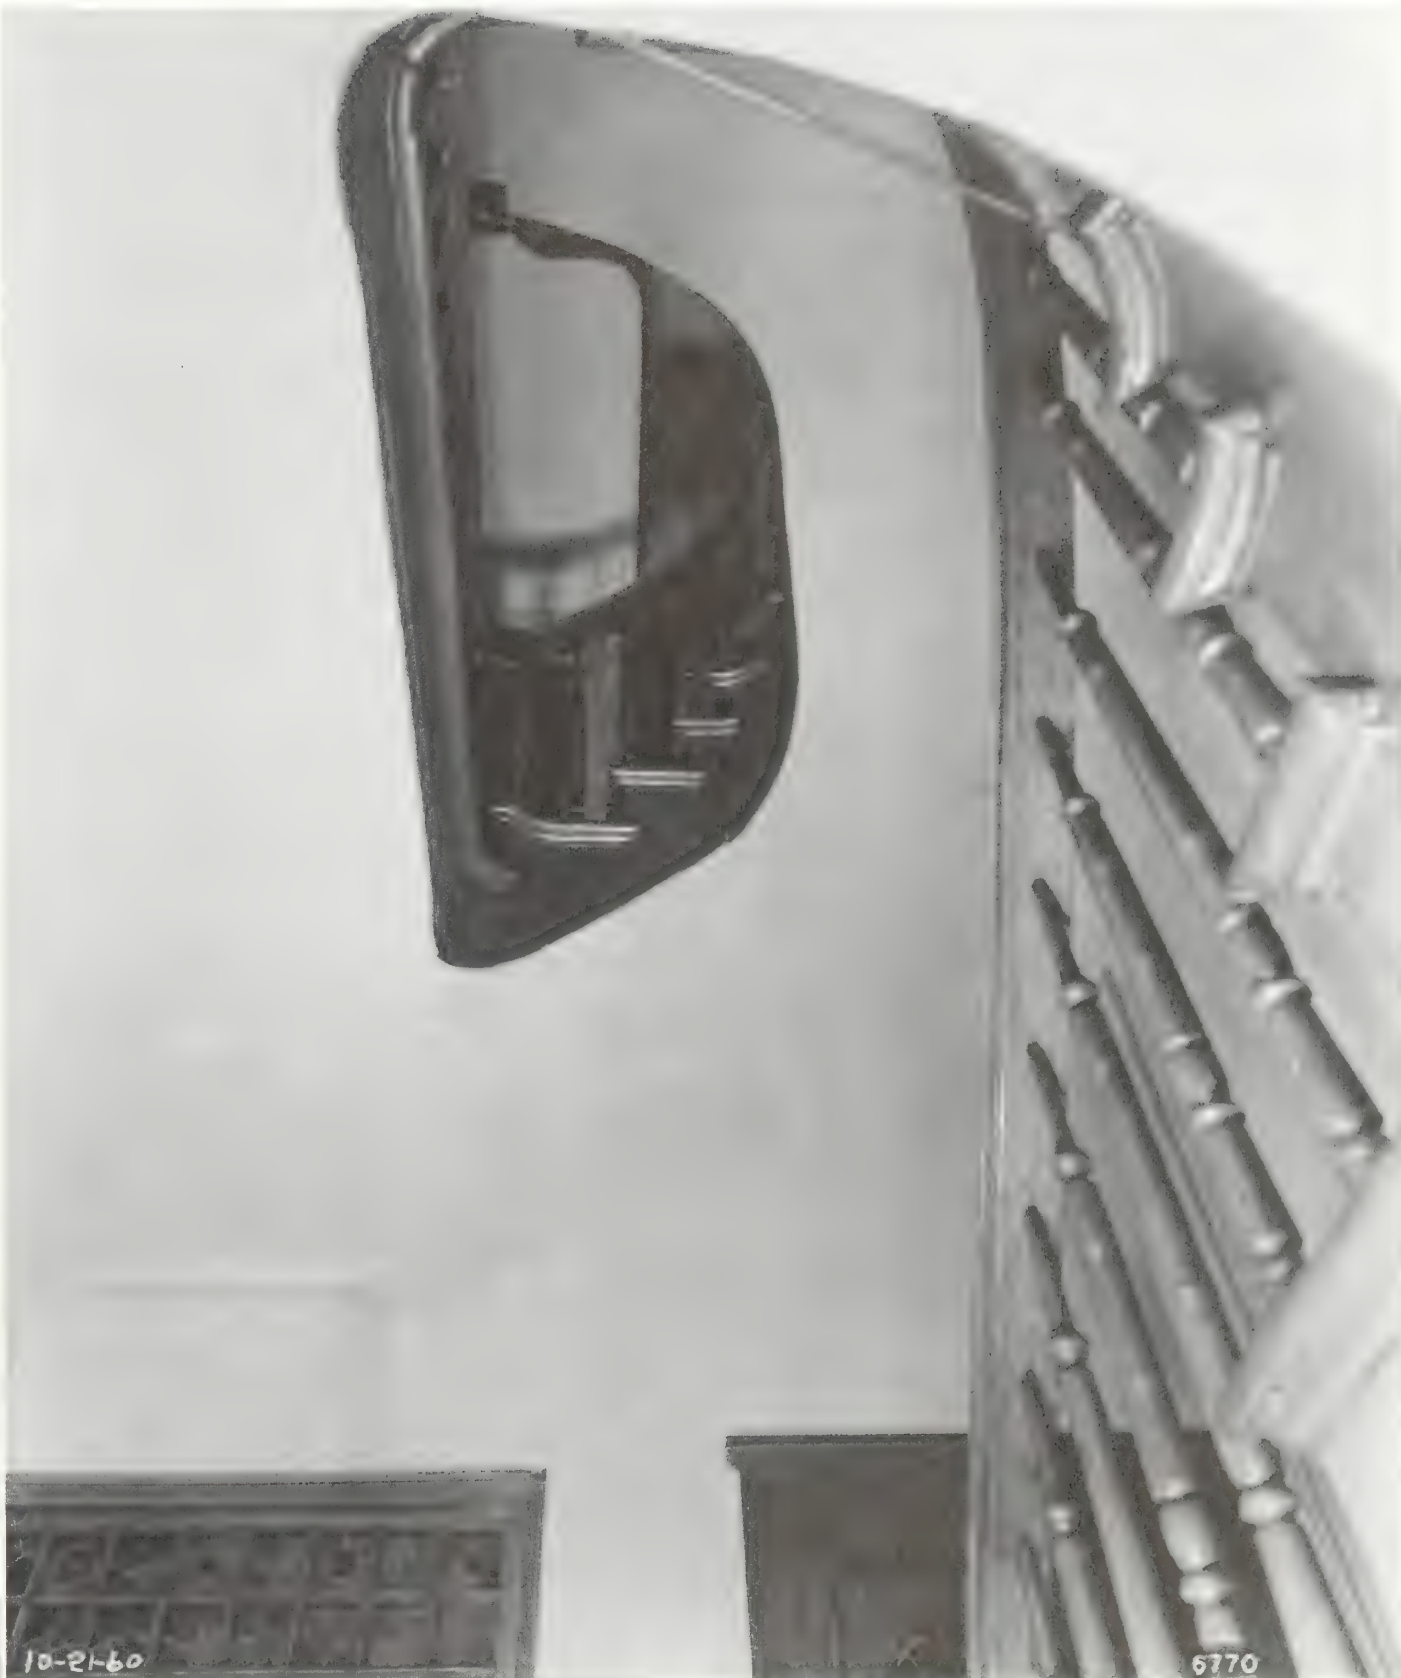
Figure 116. South part of Service Hall (Room 117), looking up at the Service Stairway, 1960.
